PACSystems* RX3i

IC695CRU320

Redundancy CPU

GFK-2514F
August 2010

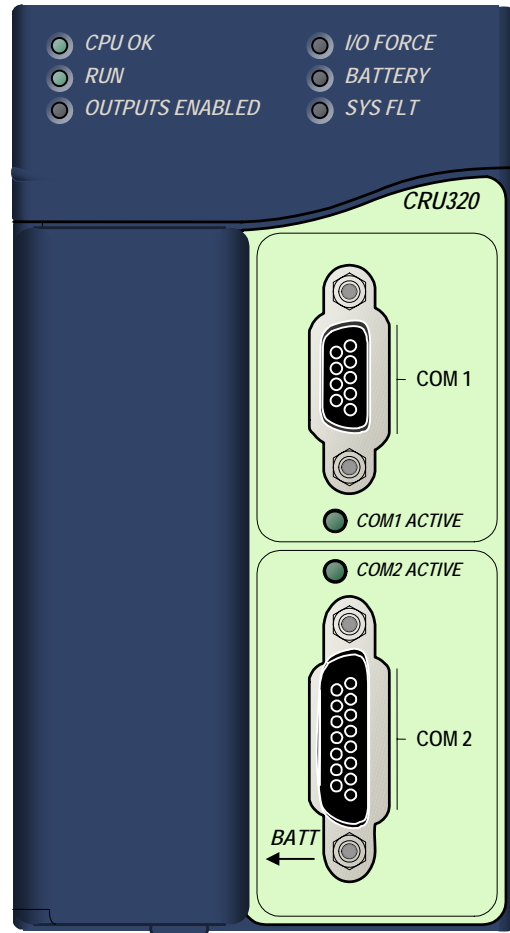
The PACSystems* RX3i Redundancy CPU can be used to perform real time processing and discrete automation for various applications. The CPU communicates with the programmer and HMI devices via serial SNP Slave protocol. It communicates with I/O and smart option modules over a dual backplane bus that provides:

- In-system upgradeable firmware.
- Two serial ports: an RS-485 serial port and an RS-232 serial port.
- Ethernet communications via the rack-based Ethernet Interface module (IC695ETM001). For details, refer to *TCP/IP Ethernet Communications for PACSystems User's Manual*, GFK-2224.
